Manhole Inspection Summary

Manhole # S39WW_047MH

Insp Date: **12/19/06 8:24 AM**

Location Address: **901 MONTPELIER ST**

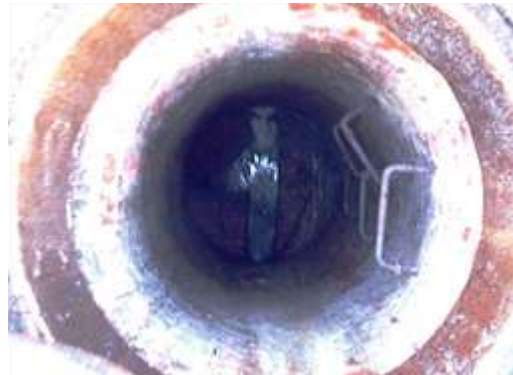
Top View

Barrel infiltration. Corroded steps. Bench debris.

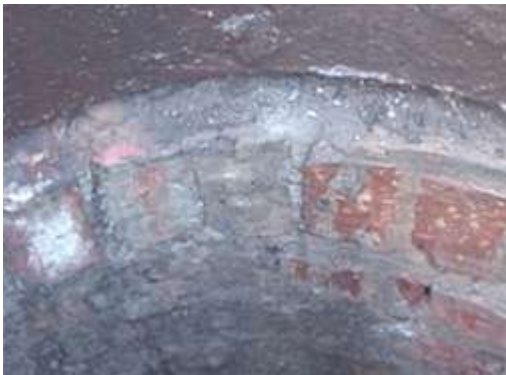
Defect

Frame leaks. Adjustment deterioration and infiltration.

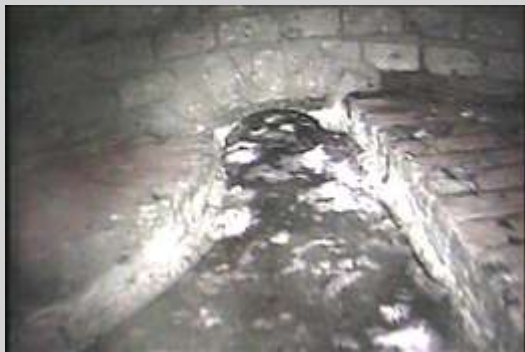
8 in. Circular Gravity Sewer Pipe Out @ 12 O'Clock

Deposits: ☐ None ☒ **Mud** ☐ Sludge ☒ **Debris** ☒ **Grease**

Silt Depth: **5** (in.) Deposits Extent: **Heavy**

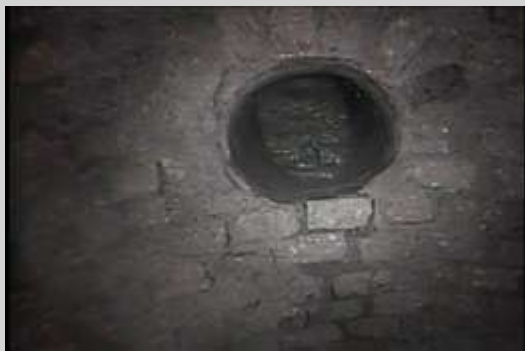
8 in. Circular Gravity Sewer Pipe In @ 6 O'Clock

Deposits: ☐ None ☒ **Mud** ☐ Sludge ☒ **Debris** ☒ **Grease**

Silt Depth: **2** (in.) Deposits Extent: **Light**

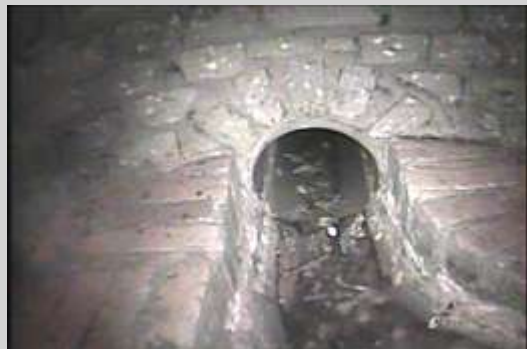
Pipe In @ 9 O'Clock

Deposits: ☐ None ☐ Mud ☐ Sludge ☒ **Debris** ☒ **Grease**

Deposits Extent: **Light**
